NZIHT TNZ Symposium – October 2003

Mercer to Longswamp Expressway (Mercer) and Project PJK (Tauranga) Instrumentation and Monitoring

This paper discusses the practical application of geotechnical instrumentation on two of the larger roading projects undertaken in New Zealand in recent years. Both projects are in areas susceptible to high settlements where a range of instruments have been installed and preloads applied.

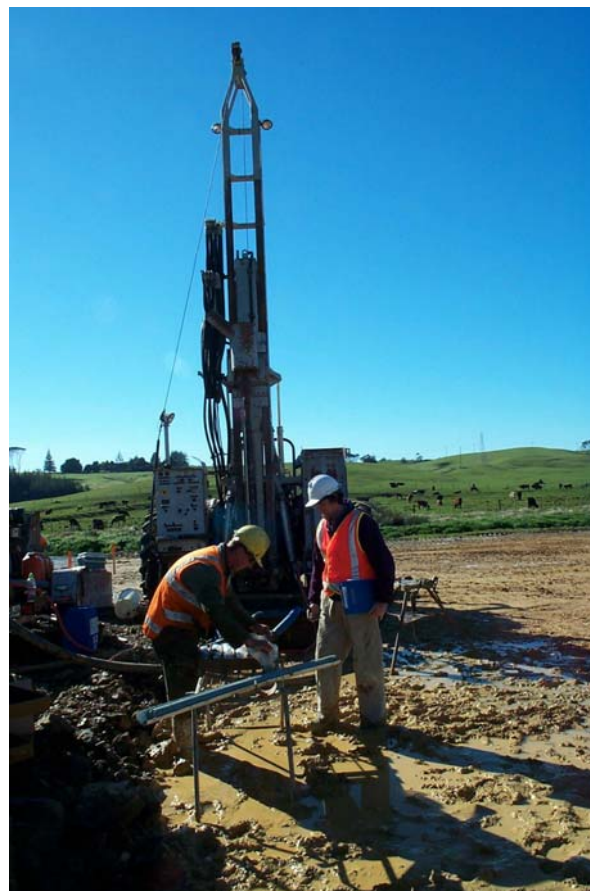
Figure 4. Installing Inclinometer / Sondex System

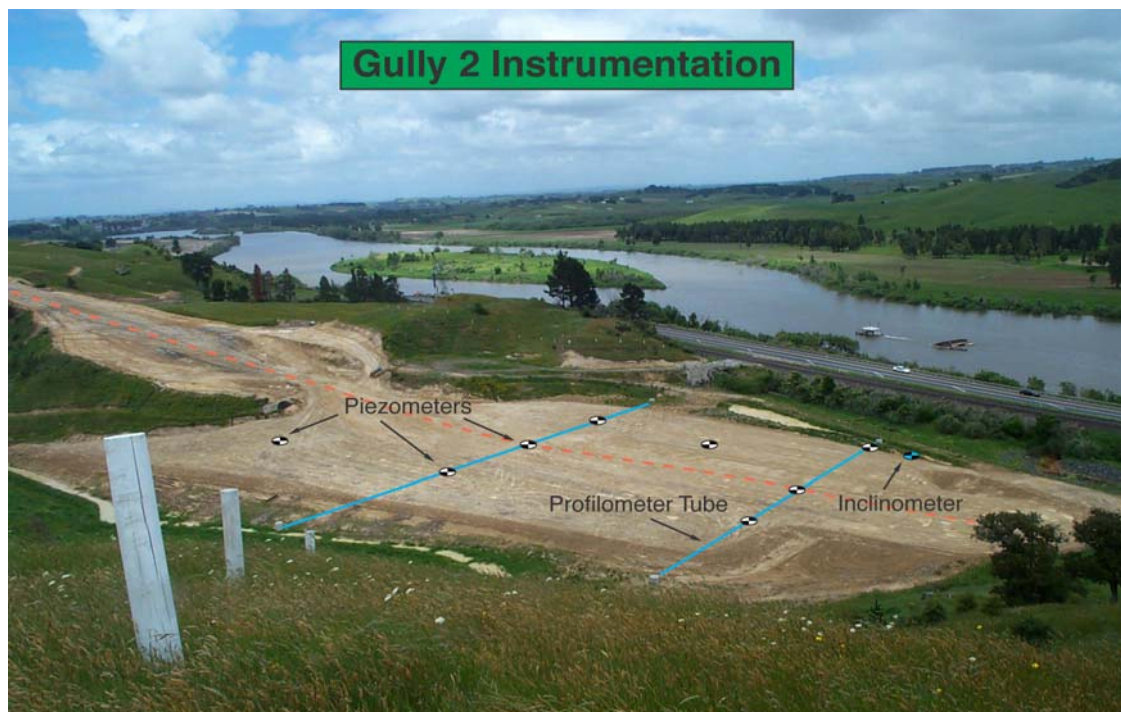
Figure 5. MLSE Gully 2 Instrumentation lines and monitoring locations.

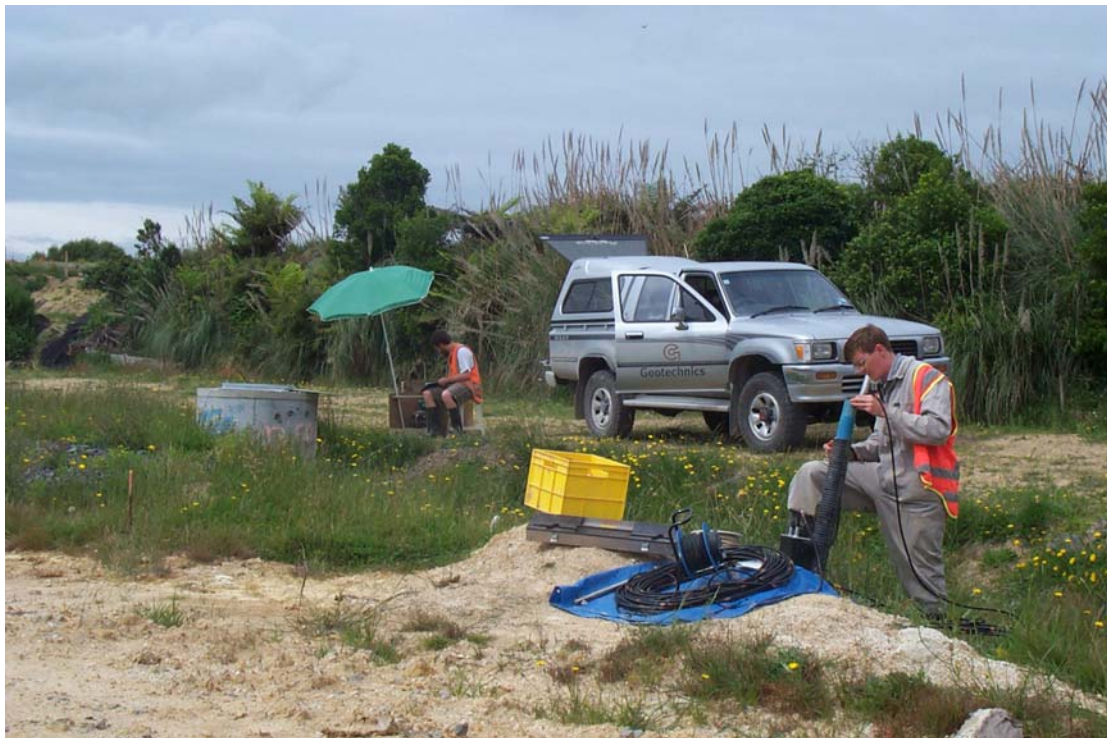
Figure 7. Monitoring of Inclinometer, Sondex and Profilometer Installations.

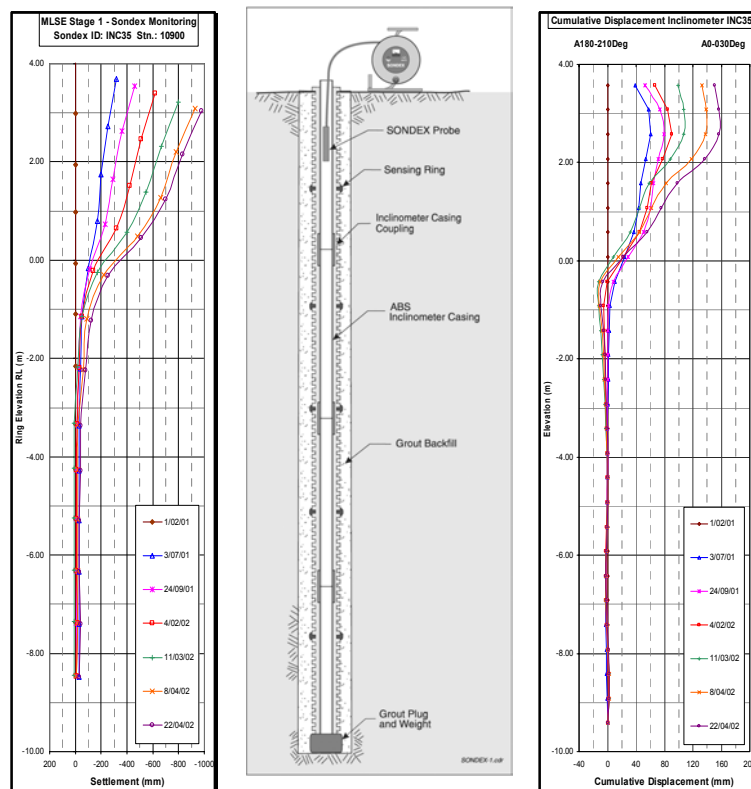
Figure 8. Comparison of Sondex Settlement and Inclinometer data.
Longswamp Crossing.

The vertical settlements observed, again closely mirrored the lateral movements within the inclinometers, with the zone of greatest compression and lateral movement corresponding.

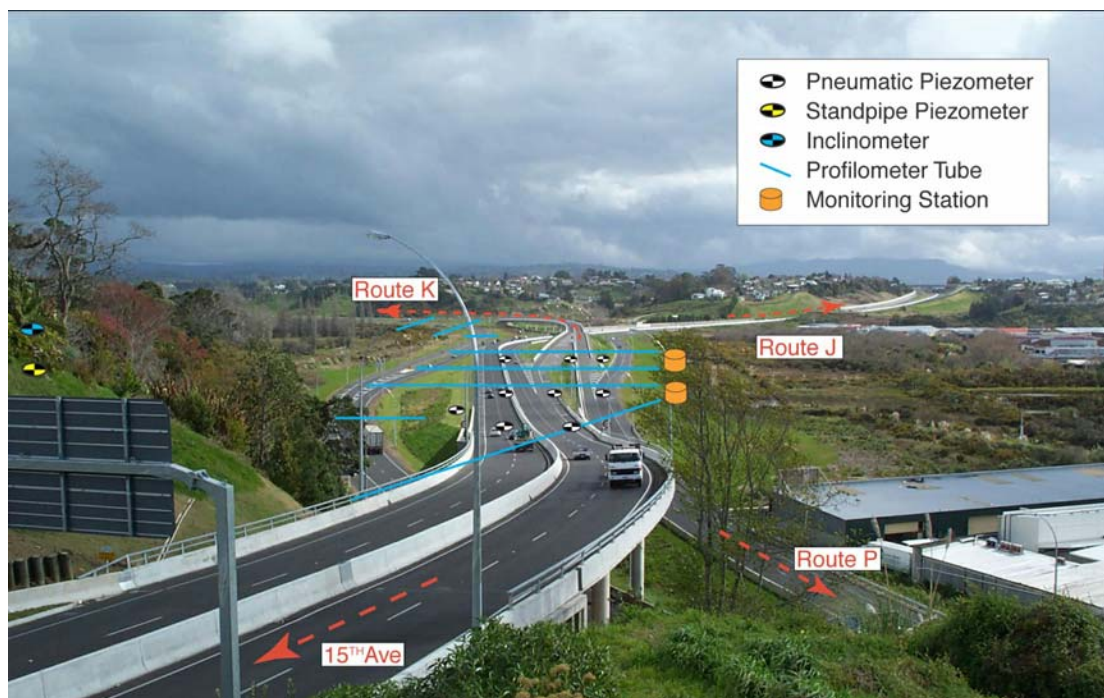
Figure 11. The completed PJK Interchange, showing instrumentation lines and monitoring locations.

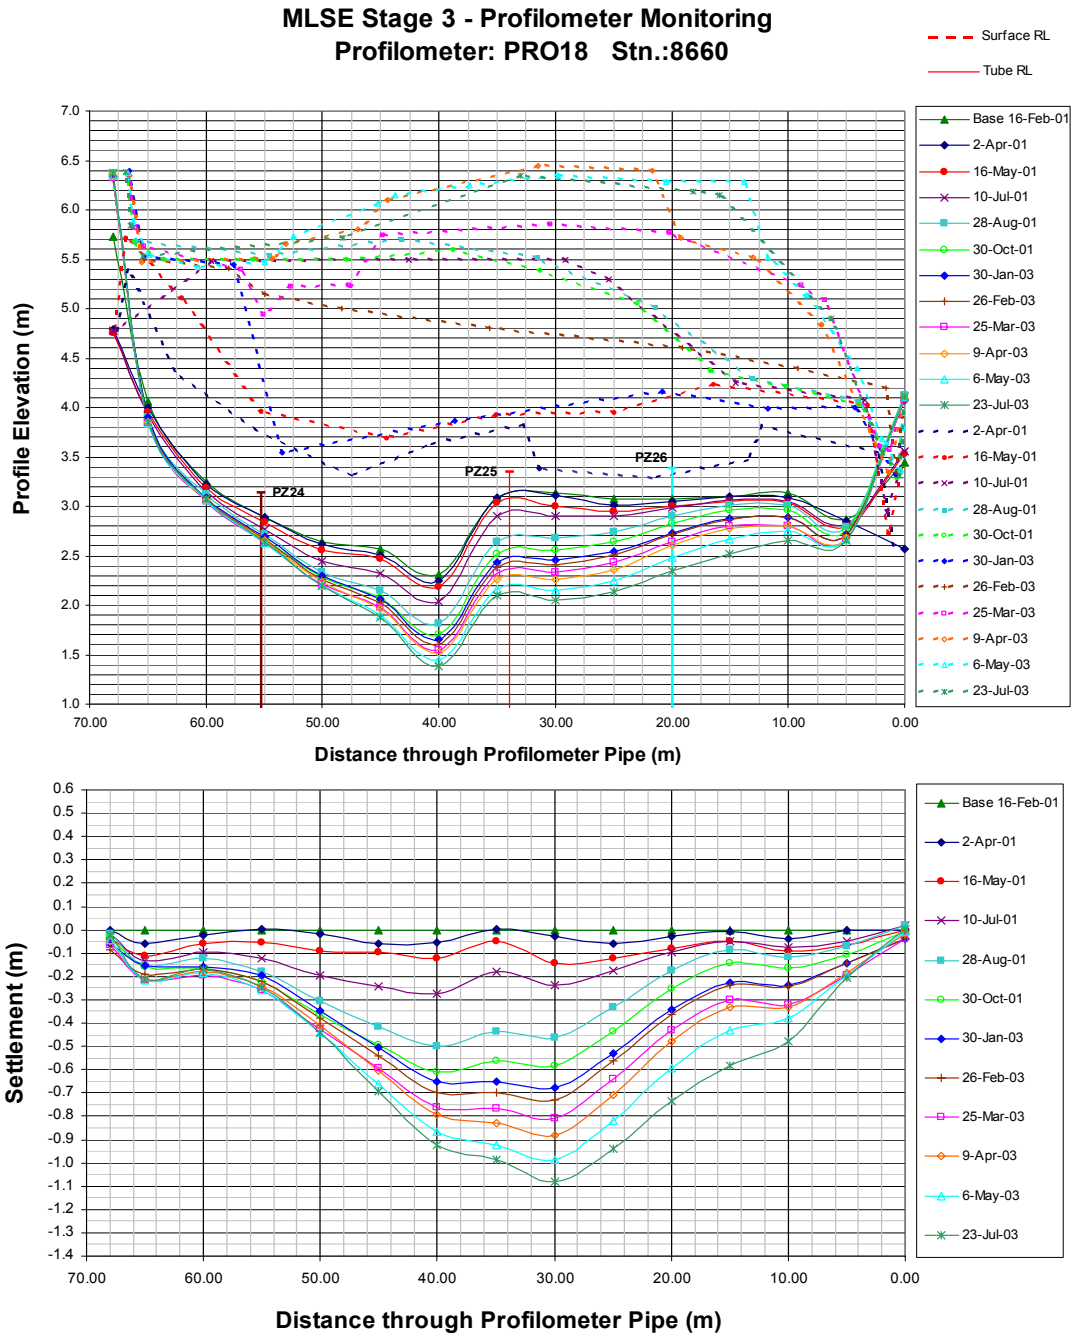
Figure 13. Graphs showing fill height and tube elevation with resulting settlement through profilometer tube. MLSE Site 3.

To meet these requirements, results were presented and reported in either hard copy or by electronic means using tables, graphs, profiles, diagrams, cross-sections and trend plots. Refer to Figures 13 and 14 for examples of result presentation.

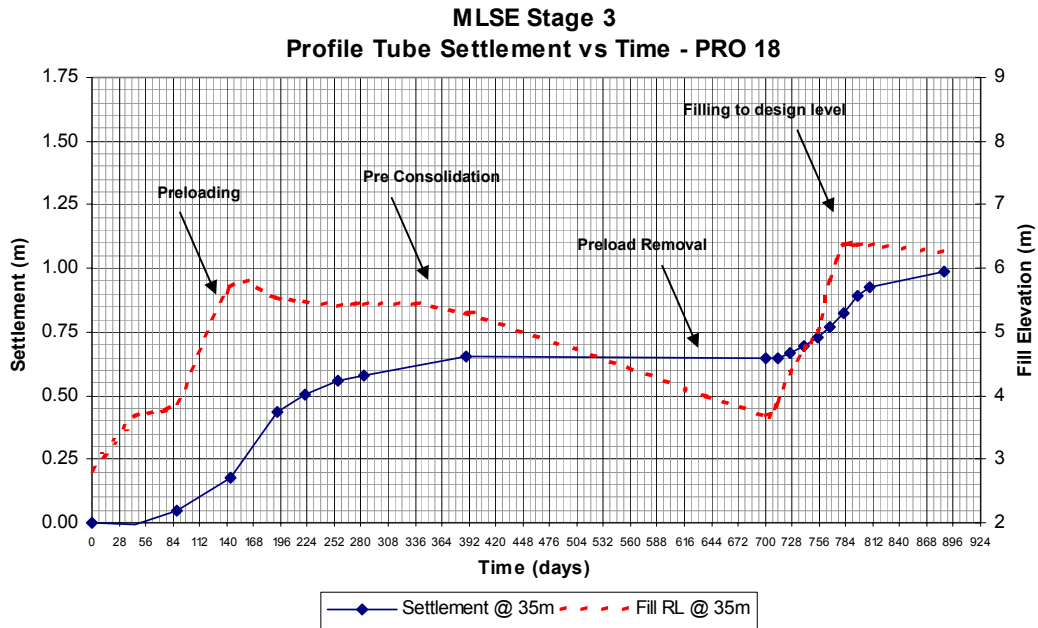
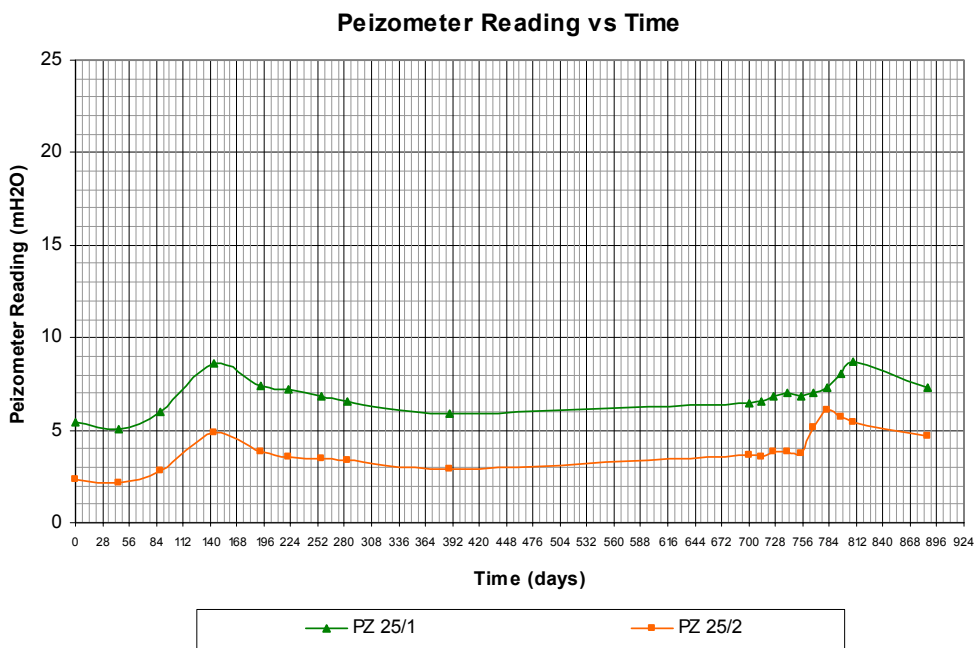
Figure 14. Graphs showing relationship between fill height, settlement and piezometric pressure. MLSE Site 3

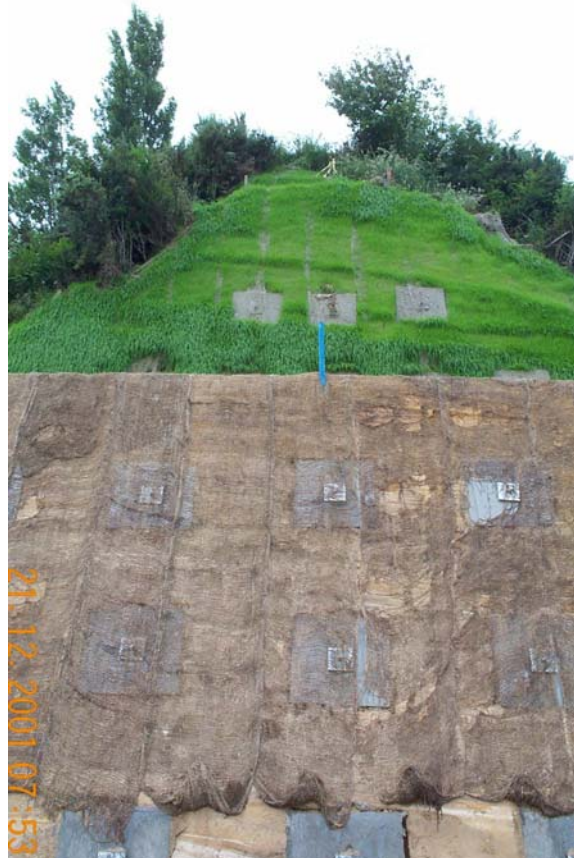
Figure 15. Soil Nailing / Inclinometer Installation. PJK. (K6 Cut)

- Instrument Damage – Due to the nature of the wick-drain installation and soil nailing operations, inclinometers, profilometers and piezometer tube lines were occasionally punctured and required re-installation.
